Report No. FAA-RD-70-15

EVALUATION OF TAXIWAY CENTERLINE LIGHTING FOR RUNWAY EXITS AND TAXIWAY INTERSECTIONS

Cecil B. Phillips

National Aviation Facilities Experimental Center

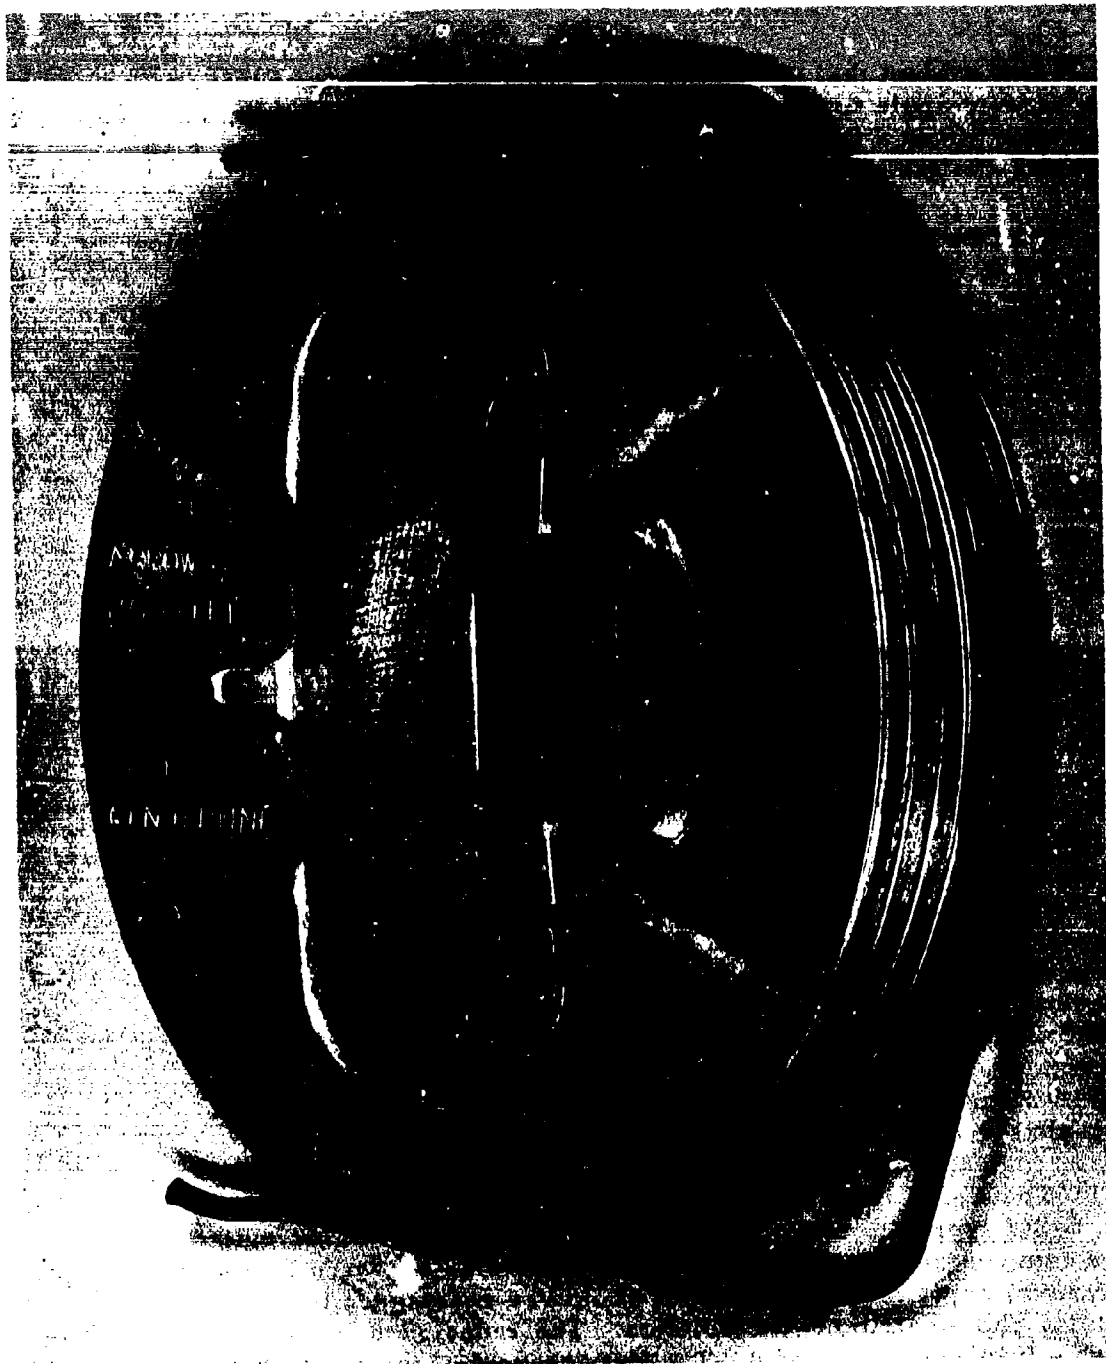
FIG. 1 L-852 INSET FIXTURE - ASSEMBLED VIEW

The Wide-Angle Taxiway Fixture: A fixture was developed to satisfy the need for an inset light with a wider horizontal beam. The resulting fixture was 8 inches in diameter, the periphery depth was 1-1/2 inch and the top surface of the light assembly sloped upward from the periphery so as to form a maximum protrusion of three-eighths inch above the adjacent paved surface when installed in the pavement. The maximum upward slope of any portion of the top surface did not exceed 10°. The lamp used was a tungsten halogen, prefocused, 6.6-ampere series lamp, with a nominal rating of 60 watts and a rated life of 1,000 hours. The lamp holder securely and accurately positions the lamp. It also provides a means of attaching a color filter as required and has a film disc cutout which immediately closes an auxiliary circuit around the lamp on failure of the lamp. Thus other fixtures in series with the failed lamp will continue to operate. The light beam has a minimum intensity of 100 candelas from -30° to +30° in the horizontal and from 0° to 10° in the vertical direction. This fixture was designated as the L-852 type of inset light. Figure 1 shows an assembled view and Figure 2 shows an exploded view of the original L-852 fixture.

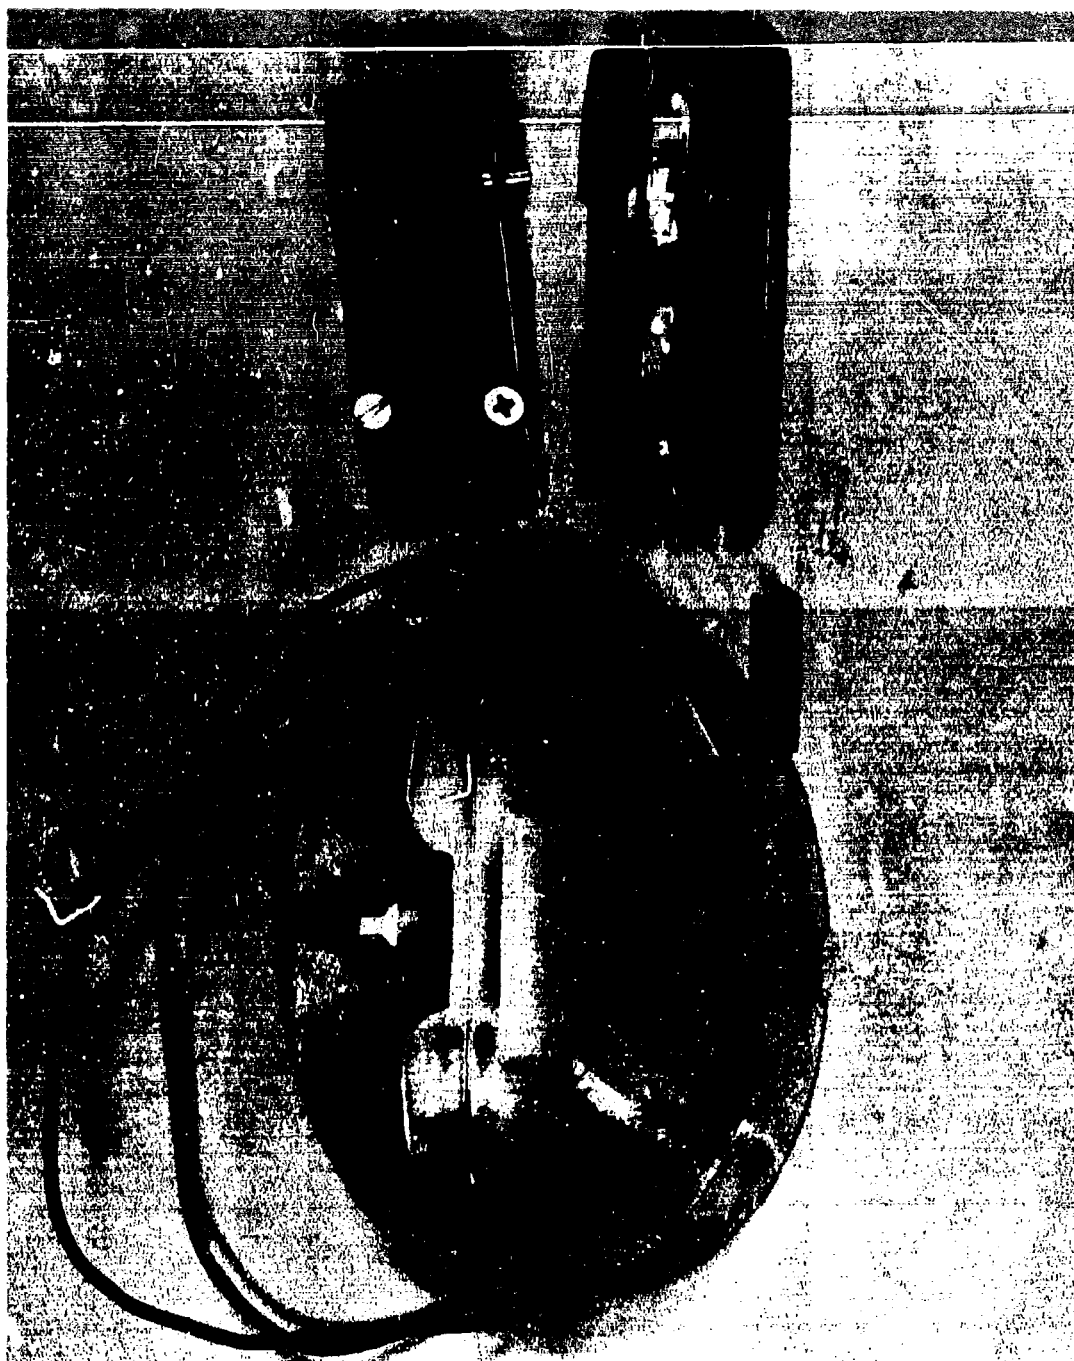
FIG. 4 THE REDESIGNED L-842 FIXTURE
WITH OPTICAL ASSEMBLY REMOVED

Taxiway A, B, and I Installations at NAFEC: The full lengths of Taxiways A, B and I were provided with centerline lighting using L-842 fixtures, (See Figure 4.) L-852 fixtures were installed at intersections of other taxiways also having taxiway centerline lighting. The L-852 fixtures were installed at a distance of 300 feet on each side of the three intersections of A and B, B and I, and B and J. L-852 fixtures also were provided within the three intersections listed above. This installation provided a system for evaluating the problem of continuing taxiway lighting across runways as well as evaluating the requirement for wide-beam guidance at intersections of taxiways.
